Wavelength Calibration, Overranges & Zero Order Troubleshooting Hints For The 4100 MP-AES

Stephen Anderson, September 2012

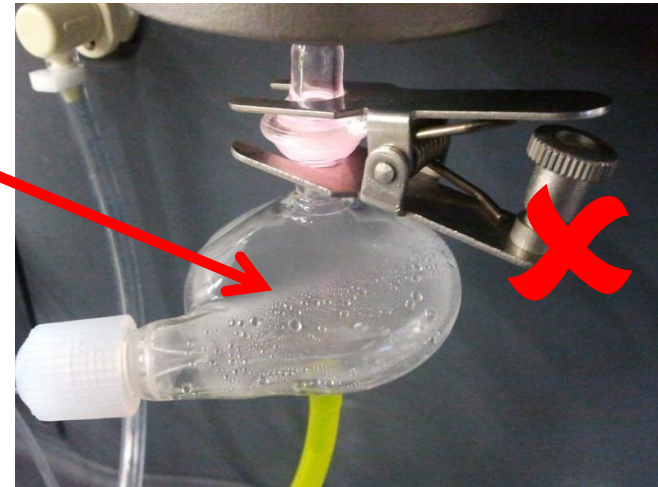
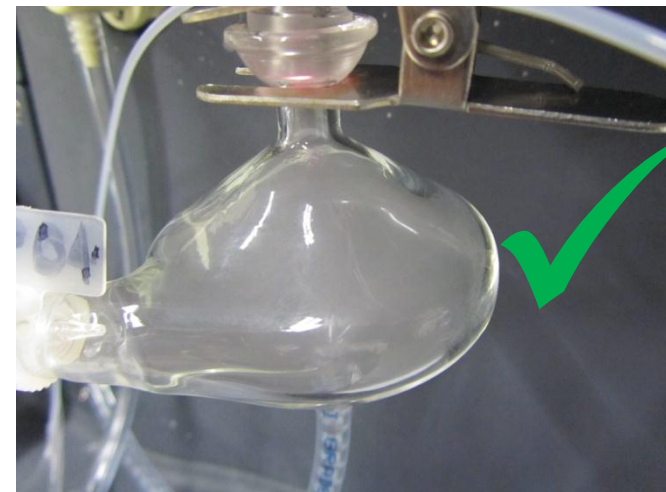
- Correctly wetting spray chamber should not have large visible droplets on internal surfaces
- If not wetting correctly clean with a laboratory grade detergent, 5%-10%
 - Problem spray chambers may need to stand overnight in the detergent solution
- After cleaning rinse the spray chamber thoroughly with Deionised water
 - Do not dry the internal surfaces of the spray chamber with compressed gases

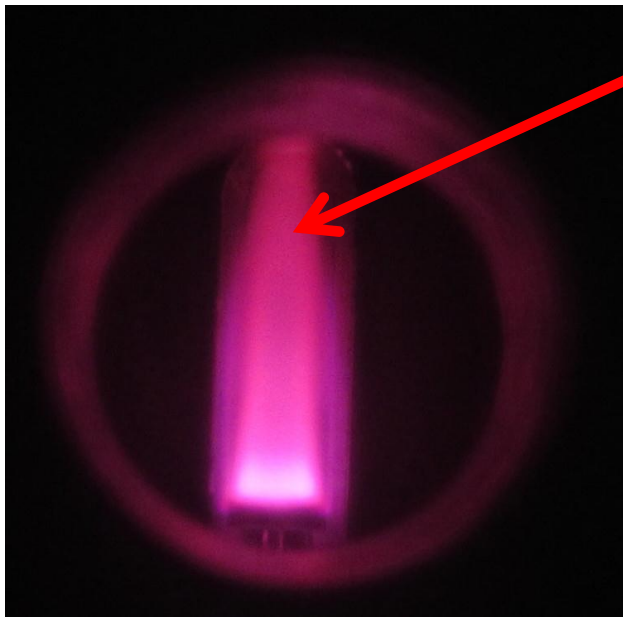
Blank

No Blue Tip

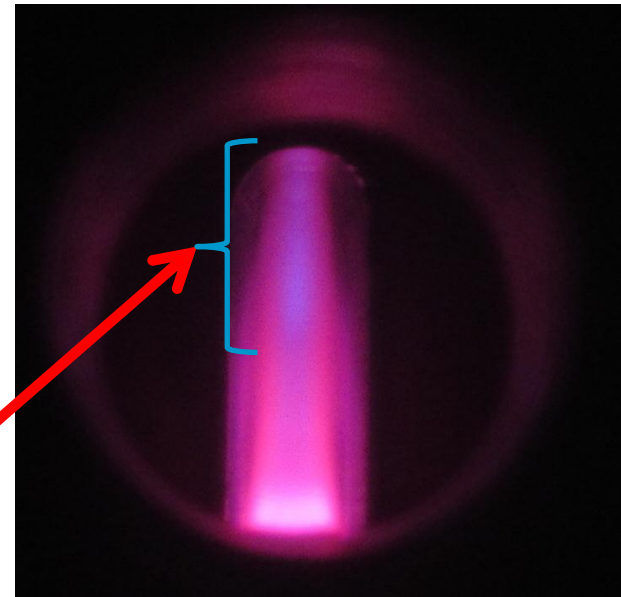
Vista Tune Solution

Blue Tip

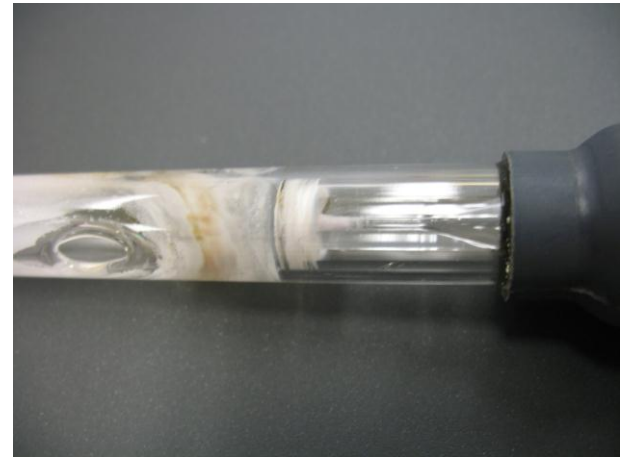
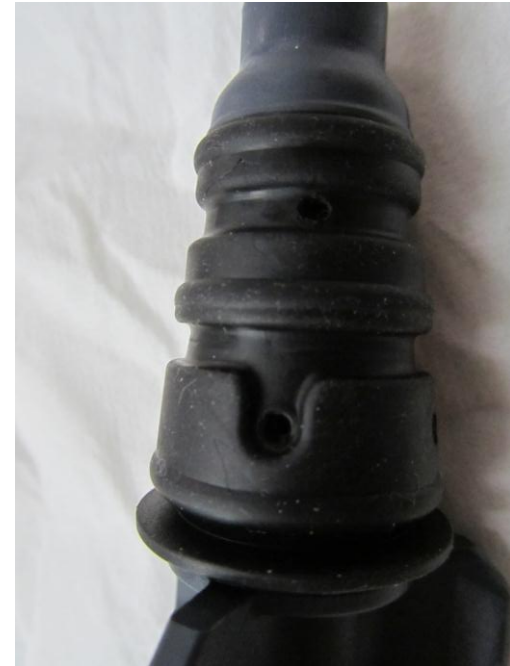
Check Torch Condition

- Plasma torch should not have any cracks or large white frosted areas (devitrification)
- Ensure the gas sealing surfaces are free of particulate materials
- Ensure gas orifices are not blocked
- Install a new Plasma Torch

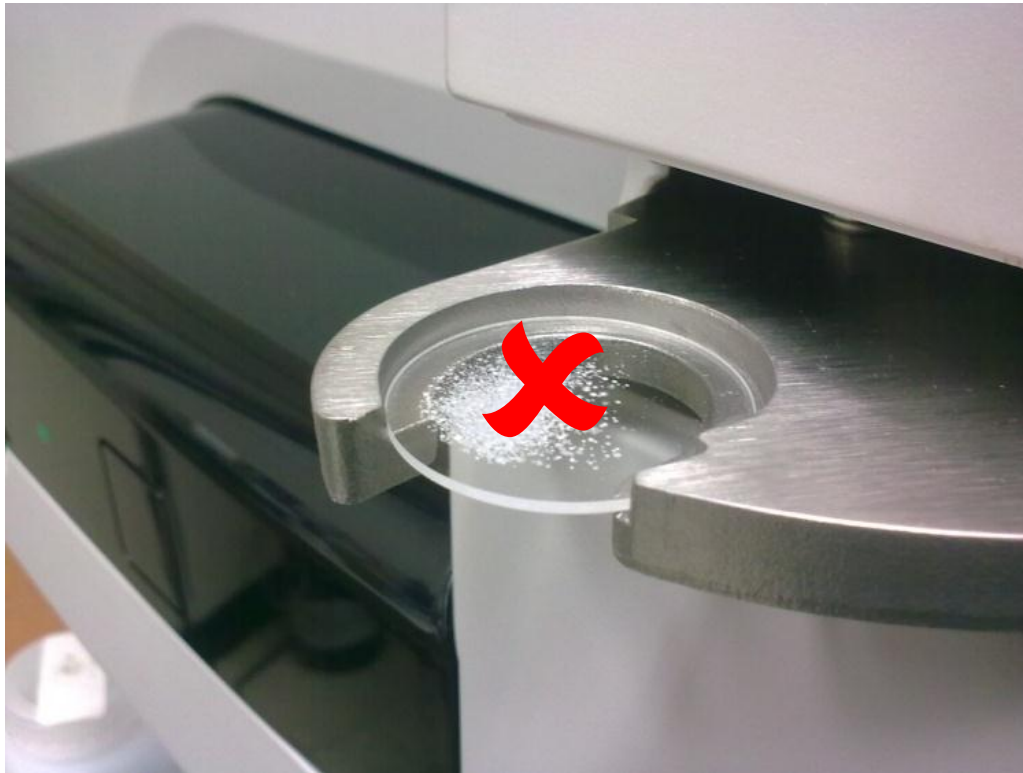
Clean the Plasma Viewing Window

- Plasma viewing window should NOT have any deposits or coatings
- Clean or replace

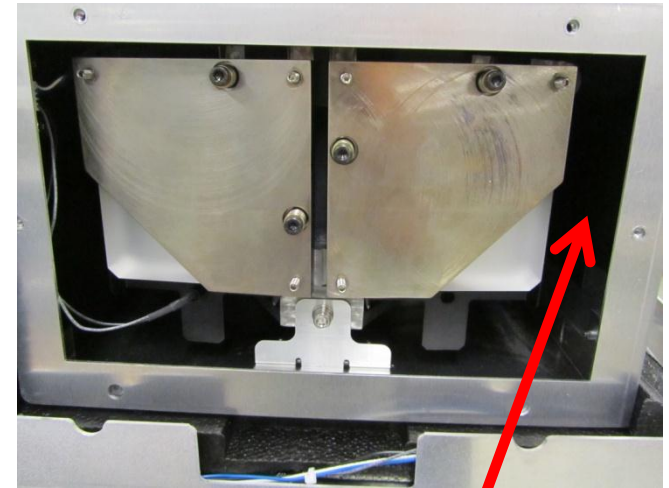
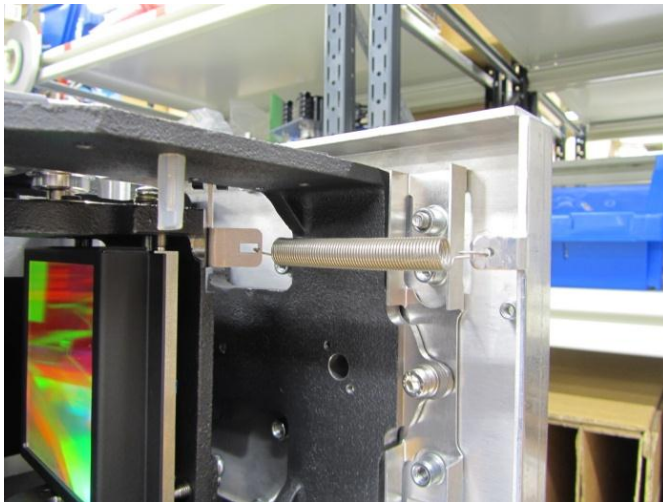
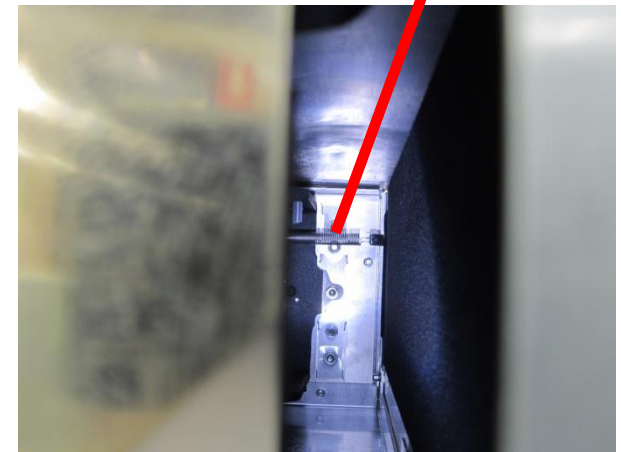
Monochromator Drive Load Spring Detached

- If correctly connected the spring should be visible at the grating end of the Monochromator by removing the back panel to the Monochromator
- If not visible reattach, requires Monochromator cover removal
- Ensure dust free environment before removing Monochromator covers

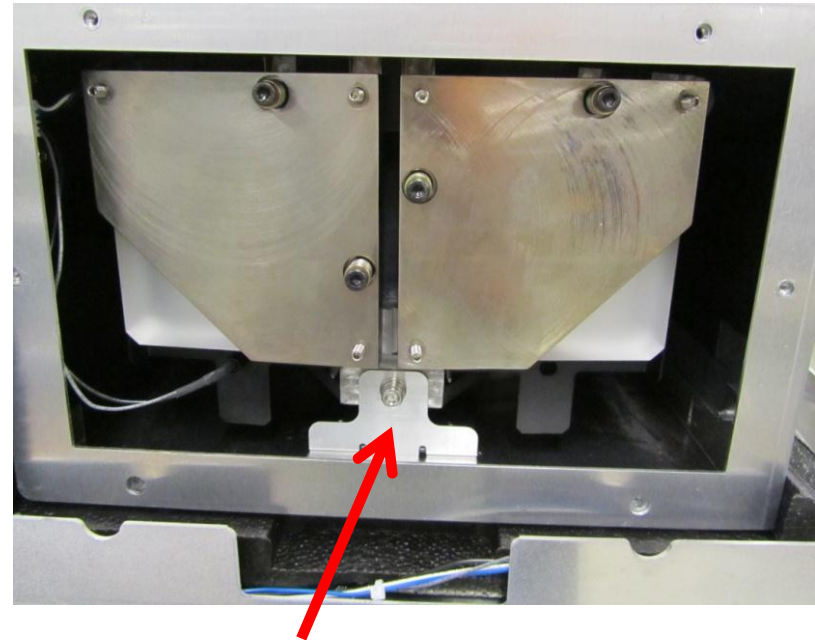
Damaged Monochromator Support Bracket

- When subjected to sudden excessive forces, the rear Monochromator support bracket has been known to suffer significant distortion
- Remove the rear Monochromator panel and inspect the bracket
- Ensure dust free environment before removing Monochromator covers
- If the bracket is distorted consider Monochromator replacement
