Wavelength Calibration, Overranges & Zero Order Troubleshooting Hints For The 4100 MP-AES

Stephen Anderson, September 2012

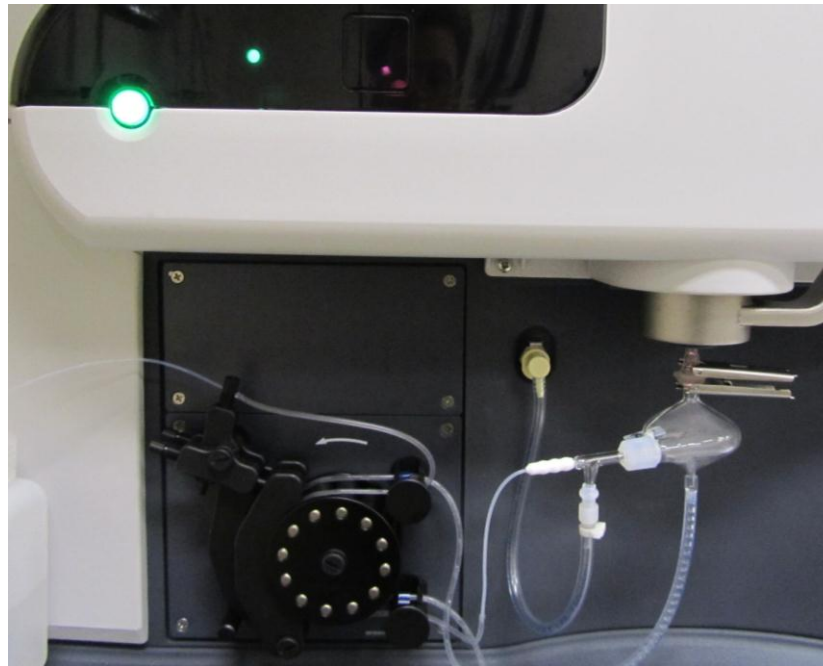
Emission Line Overrange or Peak Not Found

- Check Sample Introduction System
 - Standard Glass Concentric Nebuliser
 - White/White Sample Pump Tubing
 - Blue/Blue Drain Pump Tubing
 - Single Pass Glass Cyclonic Spray Chamber

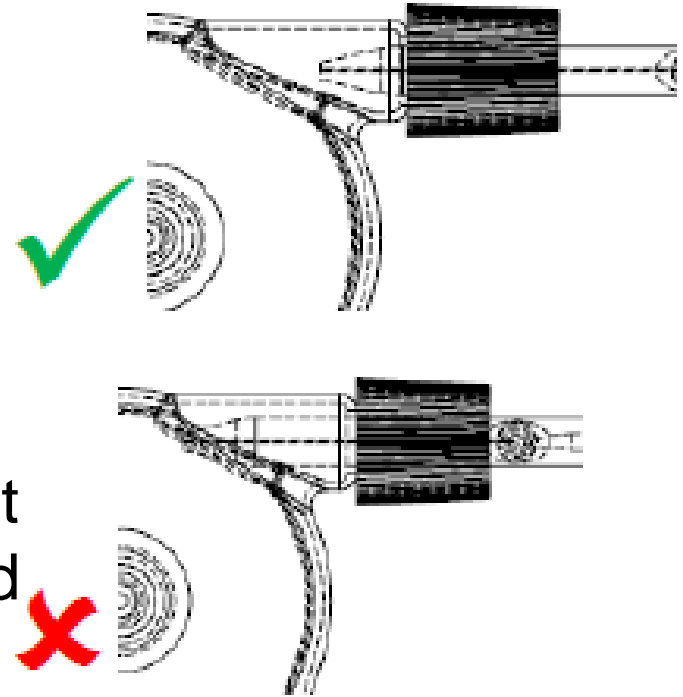
Nebulizer Position in the Spray Chamber

- Instrument performance is very sensitive to the nebulizer position in the spray chamber

- The more the nebulizer protrudes into the cyclonic action of the spray chamber the lower the sensitivity

- Carefully retract the nebulizer and observe the effect on sensitivity

- DO NOT retract the nebulizer such that the nebulizer cannot be reliably secured in the spray chamber

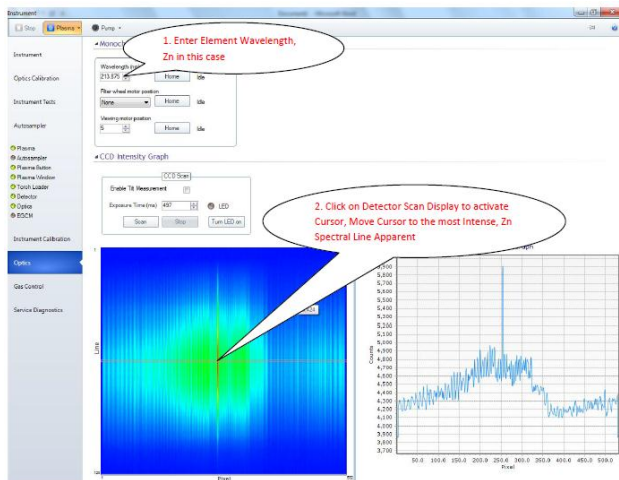
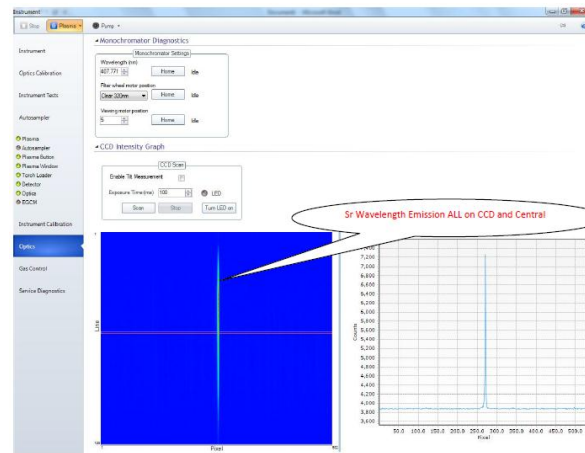
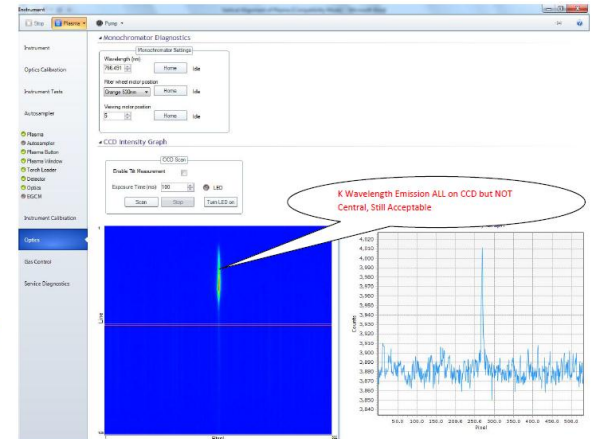
Confirm Vertical Alignment

- Impacts Performance sensitivity
- Check Low, Medium and High wavelengths
 - Usually (Zn 213.857), Sr (407.771) and K (766.491)
 - Confirm emission lines are completely on the CCD

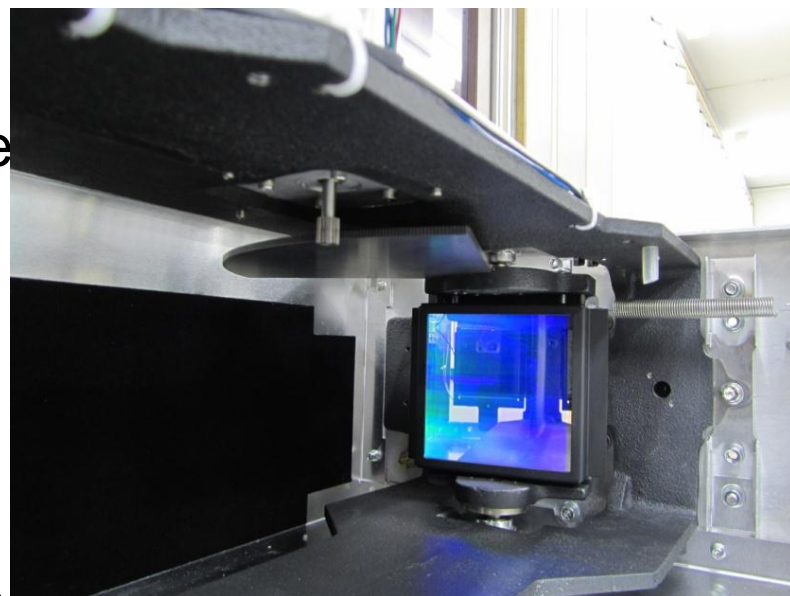
Inadequate Monochromator Stabilization Time

- Scanning of the Monochromator requires precision control
- Part of the control is a “stabilization” time which allows the grating drive components time to settle before beginning signal measurement
- Too short a stabilization time may cause OVERRANGES, resulting in a failed Wavelength calibration
- Some 4100 MP AES units have been identified to require a longer settle time
- MP Expert software releases post 1.0.2.43659 have the longer stabilization times.
